AFRL-RX-TY-TR-2011-0048

**FIREFIGHTING AND EMERGENCY RESPONSE
STUDY OF ADVANCED COMPOSITES AIRCRAFT**
Objective 3: Penetrating and Overhauling Wreckage

October 2011

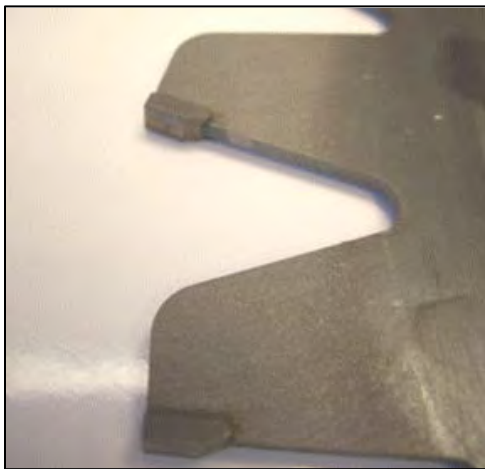
A Partner K-12, 14-in gas powered circular saw was used as the representative saw for this portion of the testing (Figure 5). The 12-in Fire Hooks Unlimited carbide blade that came standard with the saw was used for testing as this represented a general purpose blade used by fire departments for a variety of cutting needs. The circular saw blades were purchased from a firefighting equipment supplier. The blade was constructed of 24 carbide tips on a steel body that were twice the width of the body of the blade. A MK Diamond Fire Tiger Tooth 12-in diamond coated blade was used for comparison. This blade had diamond particles directly fused to a steel core. Figure 6 shows the carbide and diamond saw blade teeth.

Figure 6. Close-Up of Carbide (left) and Diamond (right) Circular Saw Blades before Cutting

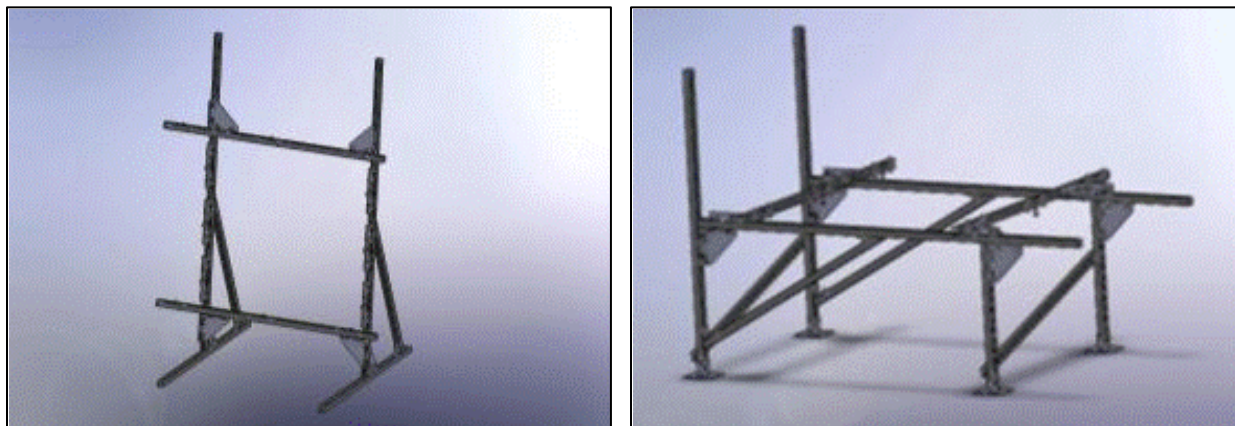
A test stand was constructed from steel Unistrut® metal framing system. This apparatus could be configured to accommodate a variety of sizes of composite sheet and could be quickly reconfigured (Figure 7). The overall dimensions of the test stand were 60-in width \times 86.6-in height; however the test stand could be adjusted to accommodate different sizes of composite samples. Figure 8 shows a composite sheet secured in the test stand. All cutting was conducted by the same person to provide some consistency in determining when the blade was no longer effective. The saw operator endeavored to apply a consistent force on the saw while cutting in an attempt to reduce inconsistencies in measured cutting speed. Cutting continued until blades were too dull to cut effectively, as determined by the operator, or until the entire sheet of composite was cut, so that cumulative lengths of material cut by each blade could be compared. The saw operator documented the perceived change in cutting ability after each sheet of composite. This

Figure 7. Test Stand in Vertical and Horizontal Orientation

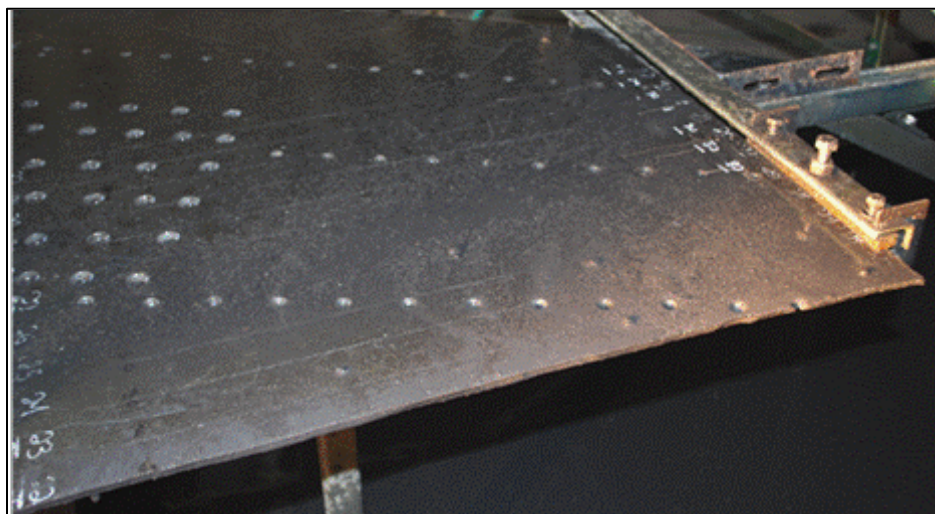
Figure 8. Composite Sheet Shown in Test Stand

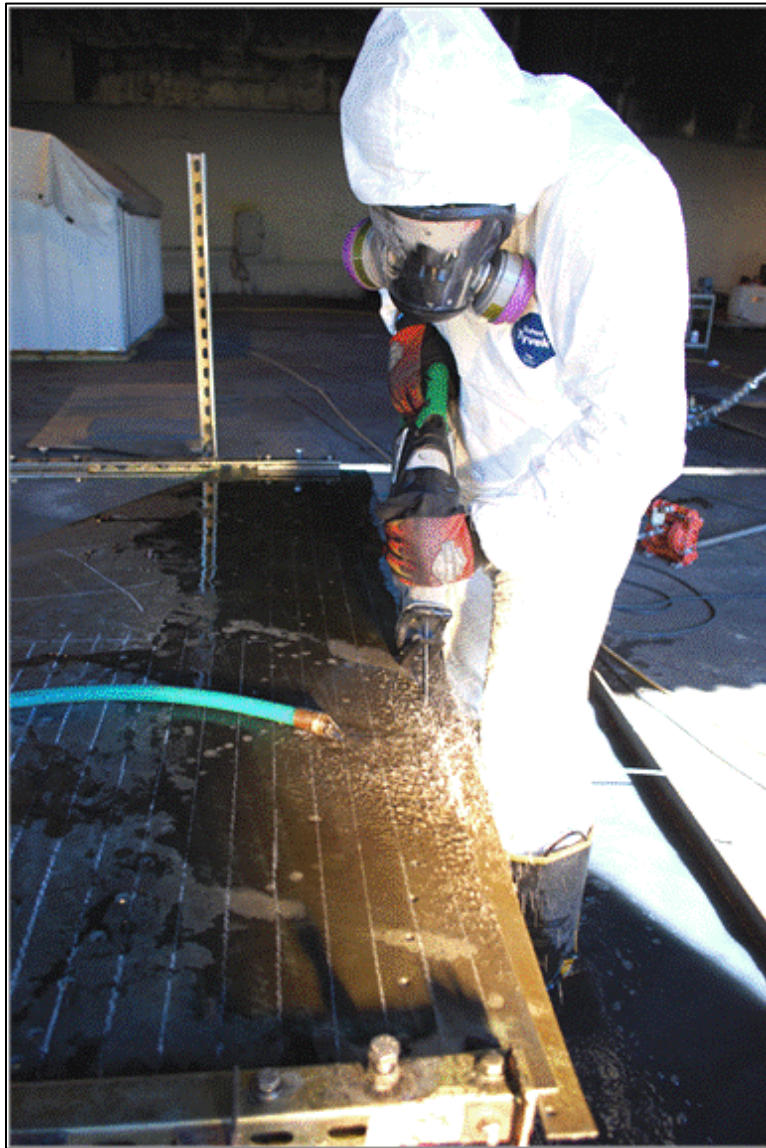
The reciprocating and circular saws were used to cut strips from F-16 composite sheets along pre-measured lines. Figure 9 shows the operator cutting with the reciprocating saw, and

Figure 9. Reciprocating Saw Being Used to Cut F-16 Composite Sheets

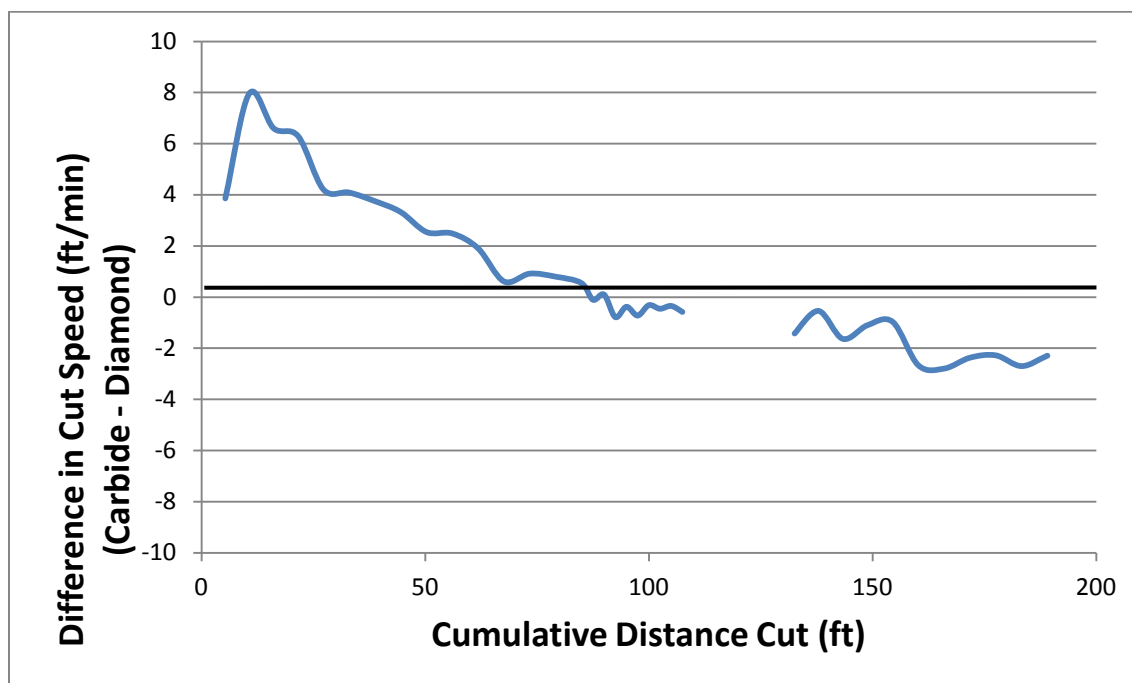
Figure 12 shows a comparison of the average cutting speed for both the carbide and diamond reciprocating saw blades. The graph shows the carbide blade cutting speed minus the diamond blade cutting speed, as a function of cumulative length cut. Figure 13 shows the total cumulative length of composite cut by each type of blade.

When the blades were new, the carbide blade cut faster than the diamond blade; however, after cutting 90 ft, the carbide blade had dulled to the point of being about equal in cutting speed to the diamond blade, and after that point the diamond blade cut more quickly than the carbide blade. After cutting 107 ft (cut number 24), the carbide blade was incapable of cutting through the sample at the thicker (≥ 0.25 in) end of the composite sample (appears as a gap in the data in Figure 12), though it was capable of cutting an additional 62 ft (up to cut number 11) of thinner (≤ 0.15 in) composite. Compared to the 169 ft cut by the carbide blade, the diamond blade was able to cut a total cumulative length of 382 ft of composite. The diamond blade had a consistent cutting speed through all three sheets of composite. The blade was still sharp and capable of cutting additional composite material; however, there was insufficient composite sample material to continue cutting until the diamond blade became too dull to cut further. Therefore the effective cutting length of the diamond blade was not determined.

Figure 12. Difference in Reciprocating Saw Cutting Speed, Carbide Blade - Diamond Blade

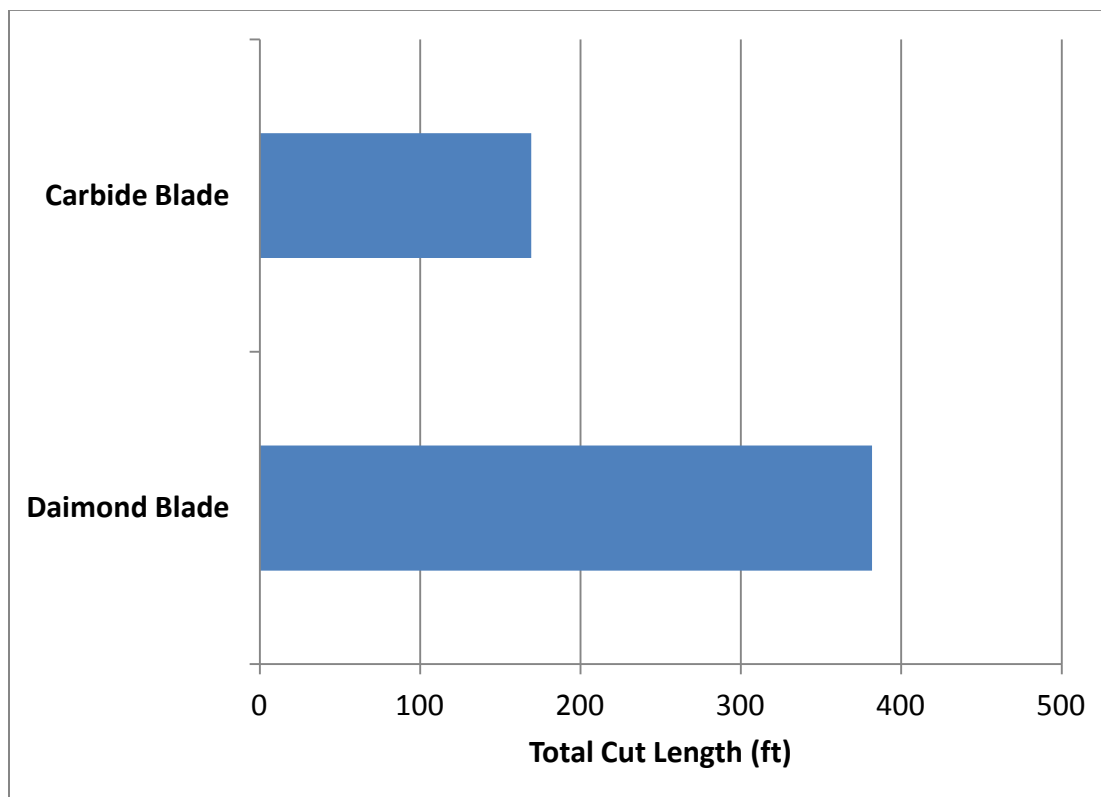
Figure 13. Comparison of Total Cut Length for Reciprocating Saw Blades

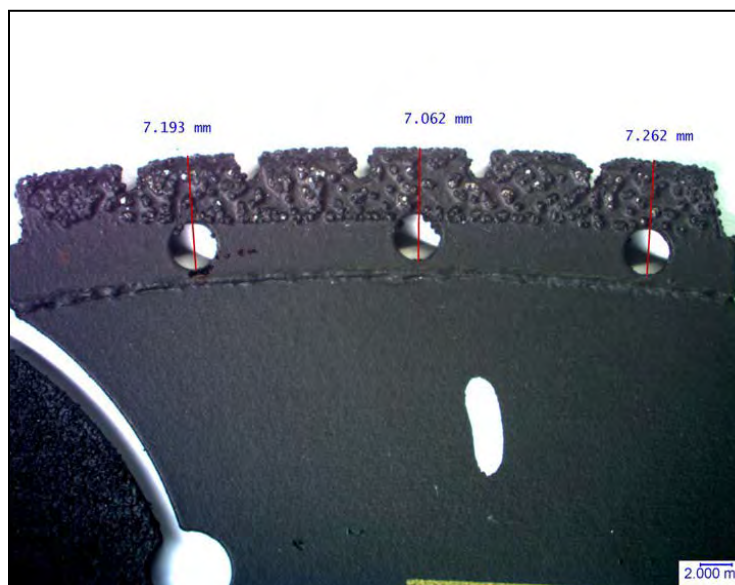
Blade wear, measured by the change in blade tooth dimensions, showed that after 255 ft of cutting the wear on the carbide blade was about one-third more than the diamond blade after cutting 382 ft. The complete report from IMR Test Labs in Appendix C shows what dimensions were measured for each type of blade. Because the design of the two blades were distinctly different, the dimensions measured for each blade were different, which makes a direct comparison of blade wear dubious. However, based on the wear to the diamond coated blade, a rough estimate of blade life can be made. Figure 16 is a photograph of a typical set of teeth on

the diamond blade, and it is apparent that diamond grit extends to about the top of the small holes, a distance of about 4 mm. If it is assumed that the blade would continue to cut effectively until the blade wore to the bottom of the v-notches, a depth of about 1.5 mm, and that the blade would continue to wear at the rate that was measured, about 0.1 mm/382 ft, then the blade should be able to cut about 5,700 ft of composite similar to the F-16 stabilizer material.

Figure 16. Diamond Coated Circular Saw Blade Teeth

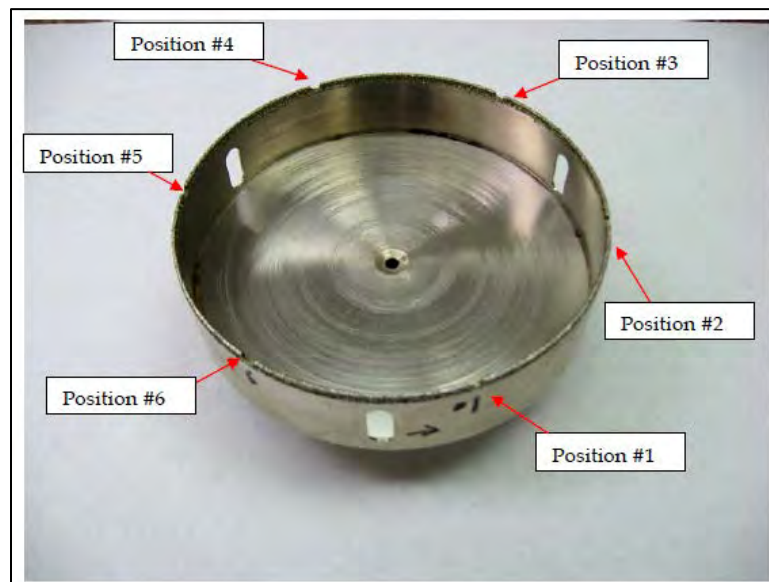
A Treasure Hong Kong (THK) Diamond Tools 6-in diamond coated hole saw (Figure 17) was evaluated. At the time of testing, THK was the only manufacturer of diamond coated hole saw blades of this diameter and could only be purchased through an eBay vendor that imported the blades from China. An American made blade of that size was not found. The hole saw measured 6 in outside diameter and could drill to a depth of $1 \frac{3}{8}$ in. The hole saw had a $\frac{1}{2}$ in shank to attach to a drill chuck and came with a pilot drill bit (not shown in Figure 17) coated with 50-grit diamond sand.

Figure 17. 6-in Diamond Coated Hole Saw

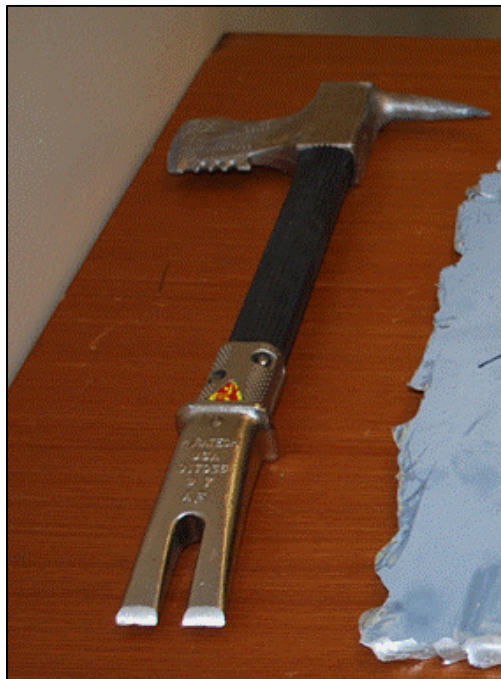
A Paratech brand Pry Axe (Figure 18) was used for all cutting. The Pry Axe was 18 in long and weighed 6.6 lb. Three materials were worked: a 0.08 in thick 5052-H32 aluminum panel; a carbon fiber and epoxy composite panel of varying thickness from an F-16 horizontal stabilizer; and, 0.05 in thick aluminum aircraft engine nacelle cowling from a KC-135. The 5052-H32 aluminum used in this test was a similar type and thickness as that used for aircraft fuselages.

Figure 18. Paratech Brand Pry Axe

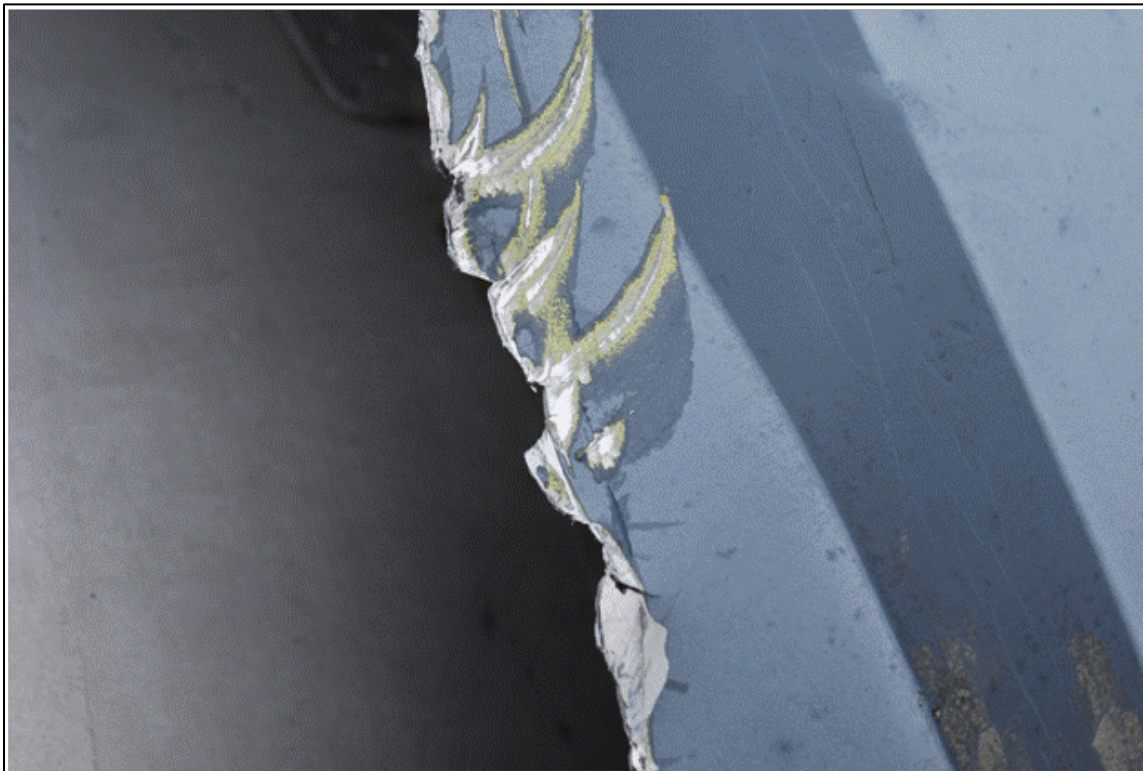
Figure 21 shows the operator using the cutting edge of the pry axe to cut a hole in the 0.05 in aluminum KC-135 aircraft engine nacelle cowling. Three 8 × 18-in holes were cut using this tool. Figure 22 shows the edges of the nacelle after cutting. Results are given in Table 5. The first hole took 56% longer to cut than the second and third holes, which was probably due to the operator becoming more proficient with experience.

Figure 22. Edges of KC-135 Engine Nacelle Cowling after Cutting with Pry Axe

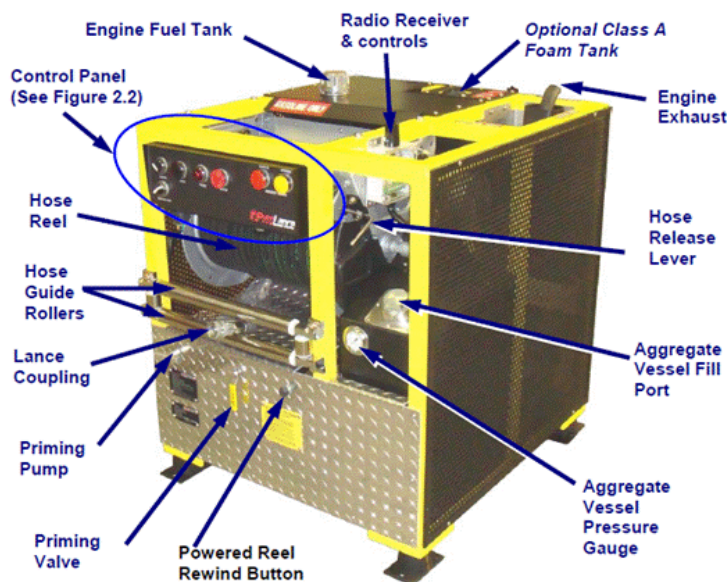
The Pyrolance (Figure 23) is an ultra high pressure cooling and fire fighting system that consists of a portable, high-pressure Lance and a gasoline-powered, high pressure pumping unit. The firefighter holds the Lance directly against the exterior of a structure and then activates it, piercing the structure with an ultra high pressure stream composed of water and aggregate. Once the exterior is penetrated, the stream from the Lance is changed to water mist or a water/foam combination to cool the interior of the space. AFRL previously conducted cursory evaluations of the Pyrolance capability to penetrate and cut through a variety of materials including carbon bismaleimide (BMI) composite, aircraft canopies, metal containers, armored plated steel and concrete block, all of which it was able to penetrate. The Pyrolance proved to be challenging and awkward to use for linear cutting, so was not evaluated for cutting in this test series. This test series focused on the abilities of the Pyrolance to penetrate multiple layers of composite material and to extinguish fires.

Figure 23. Pyrolance Schematic (excerpted from Pyrolance Operations Manual) (2)

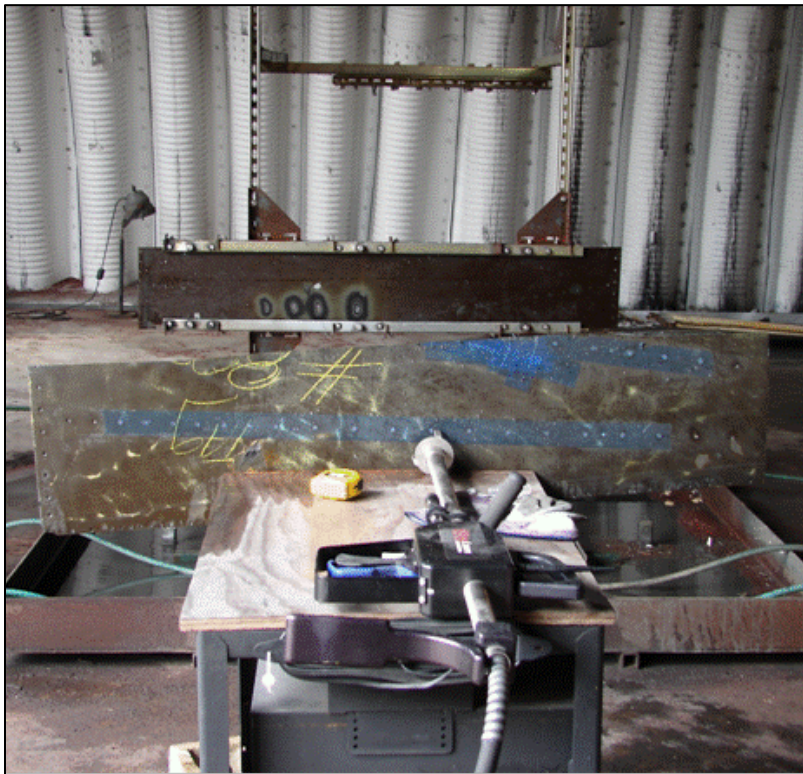
Finding the maximum piercing distance of the water jet stream between two F-16 composite panels was done with two composite panels secured in test stands and arranged parallel, starting at an interval of 5 ft. The lance was positioned against one composite sheet (Figure 24) and then discharged using water and garnet aggregate in piercing mode (10 gal/min and 3500 lb/in²). Separation distance was increased and the procedure was repeated until a distance was reached at which the Pyrolance could not penetrate the second panel.

Figure 24. Setup for Two Composite Panel Penetration Evaluations

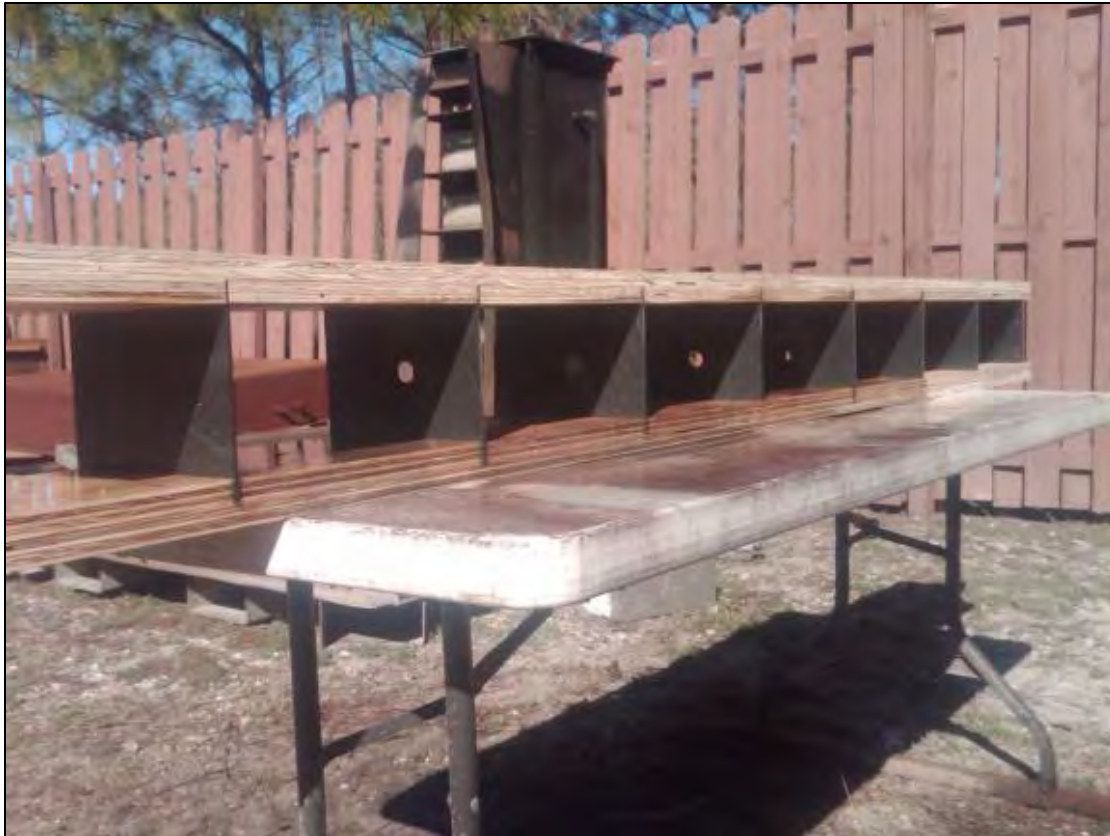
The investigation to determine how many successive composite panels the water jet stream could penetrate effectively was accomplished using eight composite panels of 0.153 in thickness secured 12 in apart in a stand specially designed for test, as shown in Figure 25. The stand was made from two pieces of 2 in thick plywood for the top and bottom, with cuts made 1 in deep every 12 in for setting the composite sheets. The Pyrolance was clamped in a stand, positioned against the first panel, and then discharged in penetration mode for 30 s. Afterward, the number of panels pierced was documented.

Figure 25. Test Stand for Multiple Panel Composite Piercing

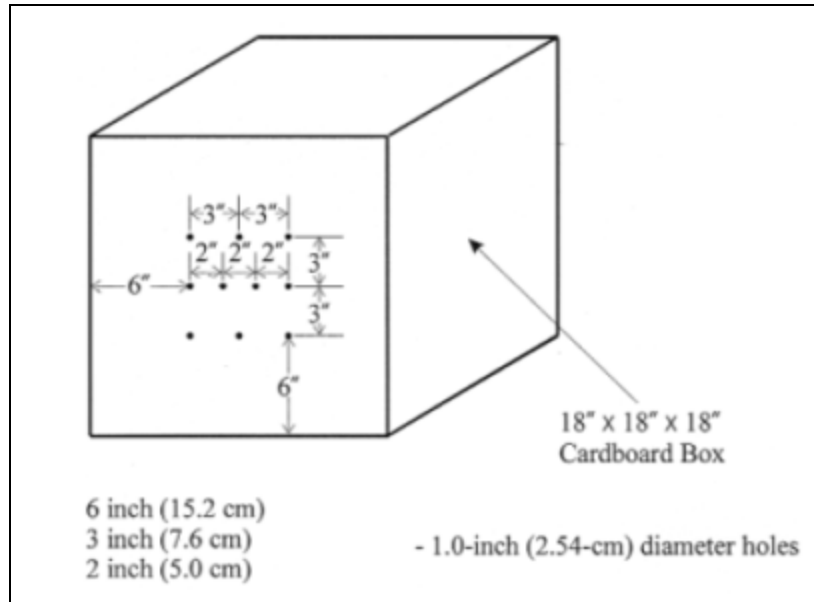
The Pyrolance was evaluated for its ability to suppress hidden fires by following the FAA Aircraft Cargo Compartment Minimum Performance Standard procedure for containerized fires. Boxes were stacked inside a mockup of a LD-3 container constructed of aluminum, sheet steel and Plexiglas (Figure 26). Two rectangular slots measuring 12×3 -in were cut into the LD-3 container in the center of the container front and in the center of the sloping sidewall for ventilation. Thermocouples were mounted on the four sidewalls of the container 8 in down from the top of the container and centered on the walls, one thermocouple was mounted in the center near the floor, and three thermocouples were equally spaced across the inside ceiling of the container, as shown in Figure 26. All thermocouples were 1/16 in stainless steel sheathed, K-type. The fire load consisted of 33 single-wall corrugated cardboard boxes, with nominal dimensions of $18 \times 18 \times 18$ -in. The weight per unit area of the cardboard was 16 lb/ft^2 . The boxes were filled with 2.5 lb of loosely packed standard weight office paper shredded into strips. The flaps of the boxes were tucked under each other without using staples or tape. The boxes touched each other to prevent any significant air gaps between boxes (Figure 27). The boxes were conditioned to the temperature and humidity of the Fire Hangar where the tests were conducted. An ignition box, which consisted of a 7 ft length of nichrome wire wrapped around four folded (in half) paper towels, was used to start a fire inside the container by applying 115 VAC to the wire. The ignition box was located at the bottom of the container directly in front of the ventilation slot in the slanted portion of the container. Ten 1-in diameter ventilation holes were cut into the front face of the ignition box facing the ventilation slot on the LD-3 container (Figure 28).

Figure 28. Ignition Box for LD-3 Container Fire

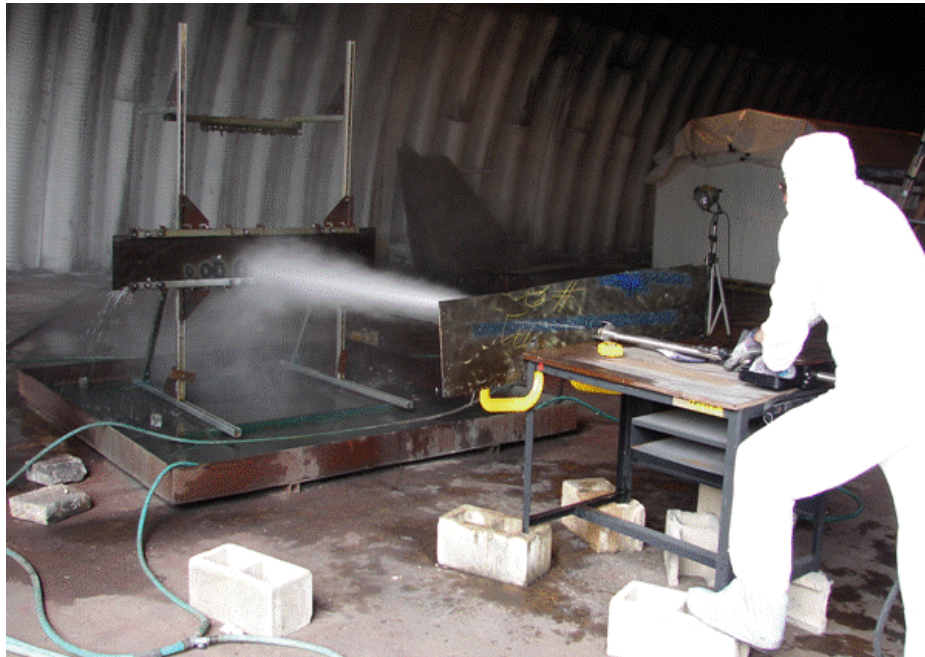
Figure 29 shows a piercing distance check in progress. Figure 30 shows the two panels used for determining maximum piercing distance. Six trials were completed to determine the distance, starting at 5 ft and working up to 9 ft (labeled T-1 and T-5 in Figure 30), which did not pierce the far panel. An additional test (T-6) was conducted at 8.5 ft, which also did not pierce the far panel. Therefore, the maximum distance was 8 ft. It can be seen in Figure 30 that the Pyrolance cut a small hole in the near panel and a much larger hole in the far panel as the water/aggregate stream started to disperse.

Figure 29. Testing the Effective Piercing Distance of Pyrolance

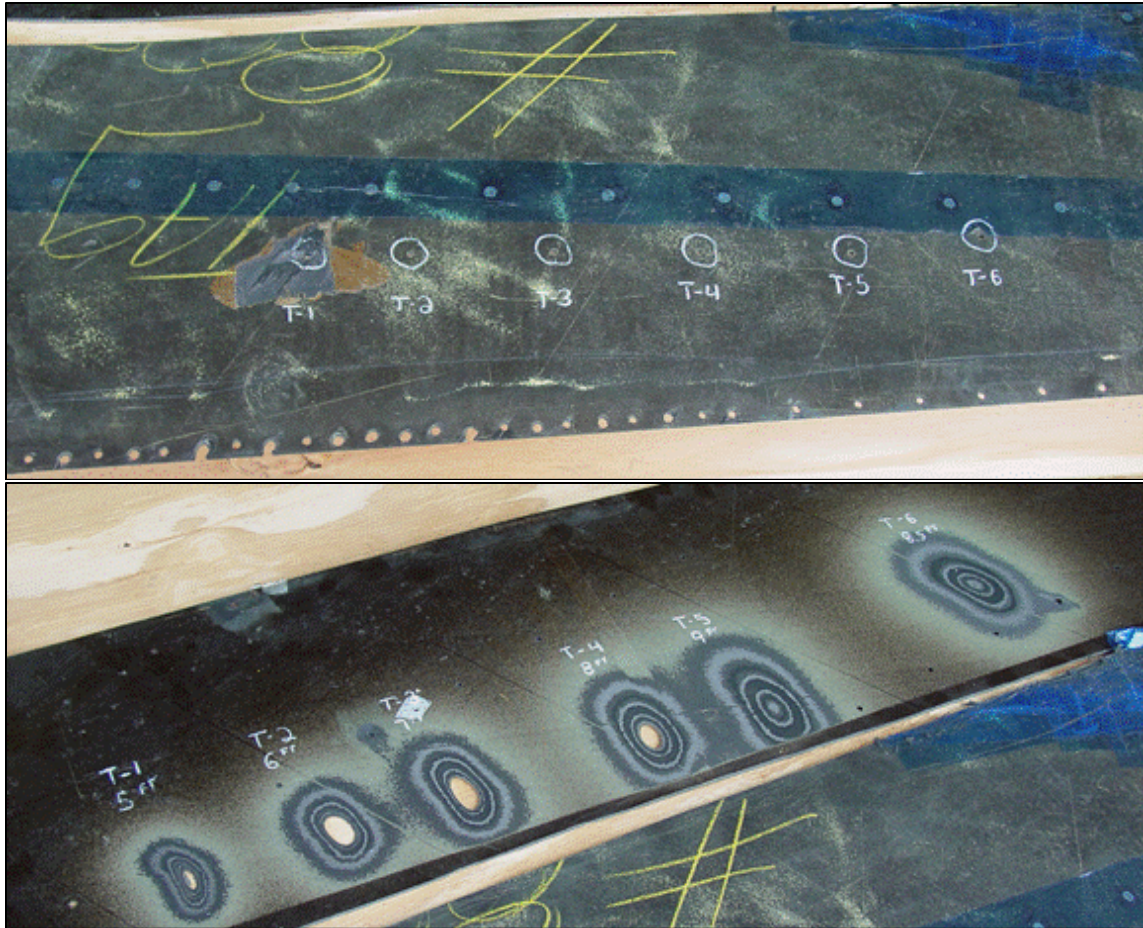
Figure 30. Panels Used for Maximum Penetration Distance Verification: (top) Near Panel; (bottom) Far Panel

Table 8 shows the results for all six piercing tests including time to pierce the panels as well as the thickness of each sample. The thickness was consistent for the front sheets, however, the back sheets increased in thickness with each subsequent test. The Pyrolance showed a maximum piercing distance of 8 ft before the water/aggregate stream became too dispersed to be effective. Piercing both sheets took just over 20 s at a separation distance of 8 ft.

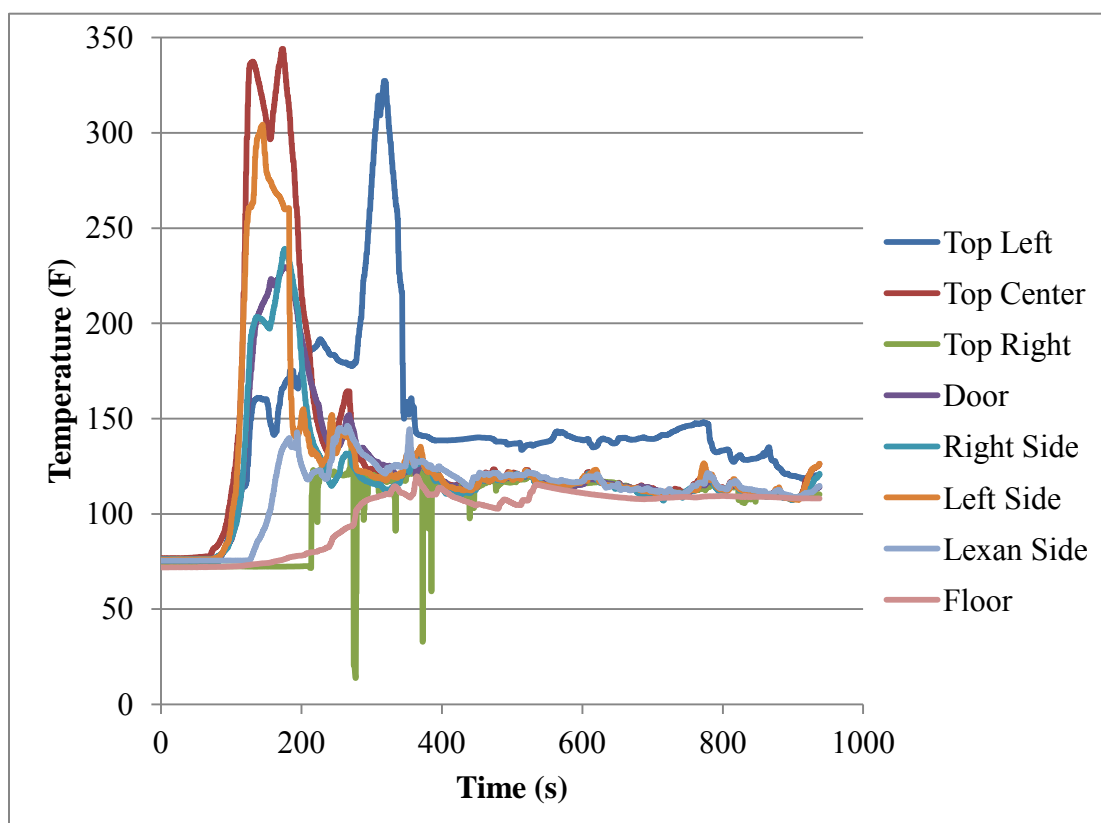
In the first evaluation the Pyrolance was used to pierce the LD-3 container at the midpoint of the slanted side, the side of the container that is normally closest to the fuselage when loaded in an aircraft. Foam and water were used. Agent was discharged for 11 min 54 s until the water/foam tank was empty. Temperatures for each thermocouple are shown in Figure 31. As expected, the temperatures around the ignition box were highest (top left, top center and left side). The temperatures at the Left Side and Top Center increased to 312 °F and 336 °F, respectively, while the Top Left increased to 319 °F. With the exception of the Top Left thermocouple (reduced to 135-145 °F), all the other temperature measurements decreased to a range of 110-120 °F once agent was applied. While the Pyrolance decreased the temperature inside the container, it did not completely extinguish the fire and several boxes continued to smolder after the water/foam tank was empty.

Figure 31. Temperatures during First Containerized Fire Test

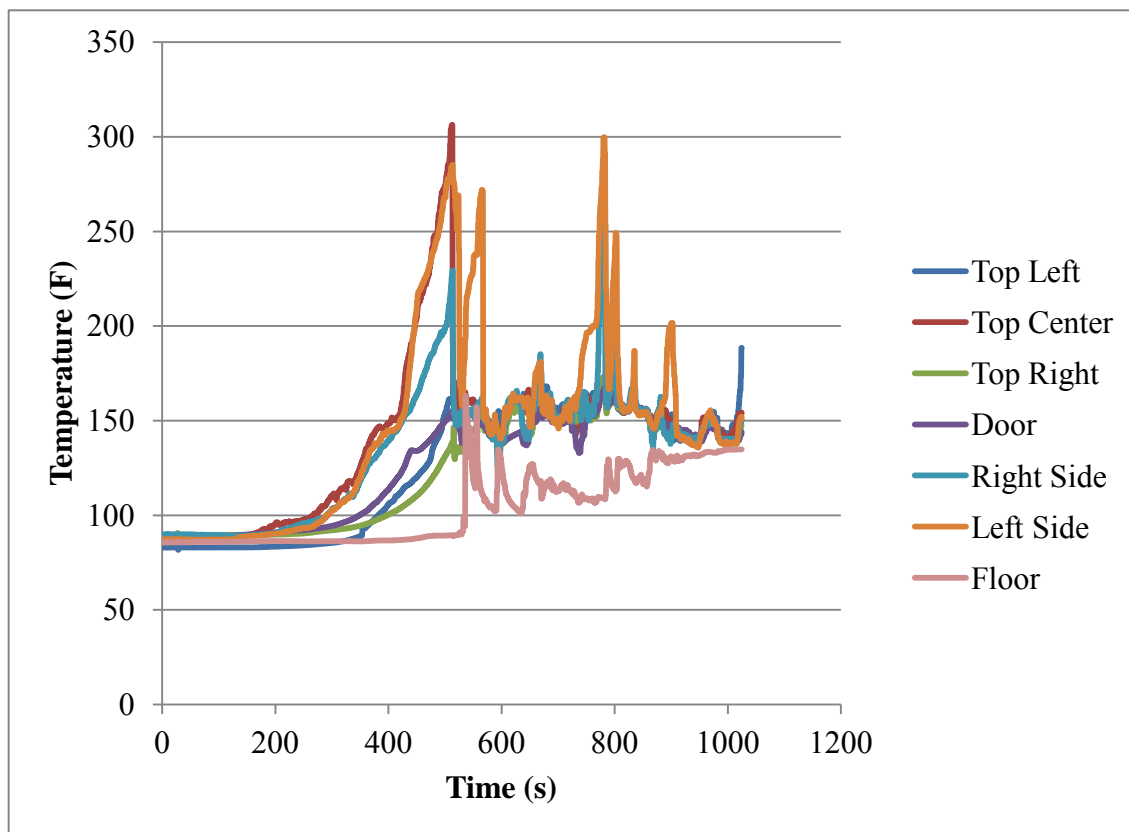
The temperatures at each thermocouple location were recorded and are shown in Figure 32. The temperature measurements for the Lexan side were deleted due to the unusually high reading as a result of the thermocouple coming in contact with the melting plastic and not providing a valid measurement of the interior temperature at that location. The temperature measurements at the Top Center and Left Side increased in a similar manner to the first test, with maximum temperatures of 304 °F and 284 °F, respectively. However, unlike the first test, the Top Left temperature never exceeded 161 °F and the Right Side temperature reached a maximum of 220 °F. Also, the temperatures fluctuated for the duration of testing, suggesting that either the foam or the single, continuous application used in the first test was more effective in the fire suppression.

Figure 32. Temperatures during Second Containerized Fire Test

Video shows that the fires were diminished several times during testing however the fire was not completely extinguished. Discharge lasted approximately 8 min 22 s. The firefighter operating the Pyrolance stated that the lance was difficult to hold after several minutes due to the weight.

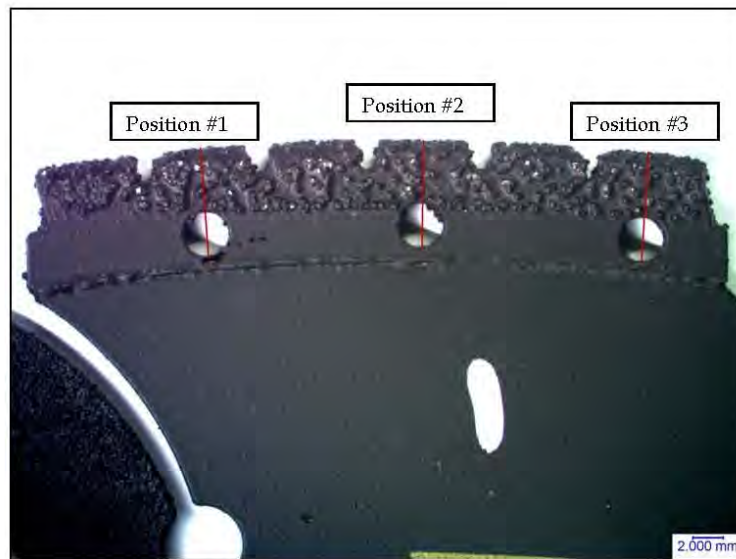
Tooth #	Position # 1 (mm)	Position # 2 (mm)	Position # 3 (mm)
1	7.193	7.062	7.262
2	7.072	7.211	7.188
3	7.137	7.175	7.153
4	7.377	7.211	7.202
5	7.099	7.212	7.333
6	7.111	7.101	7.142

Figure 1: Macrograph of Circular Saw NDL 18772, before testing, showing position locations

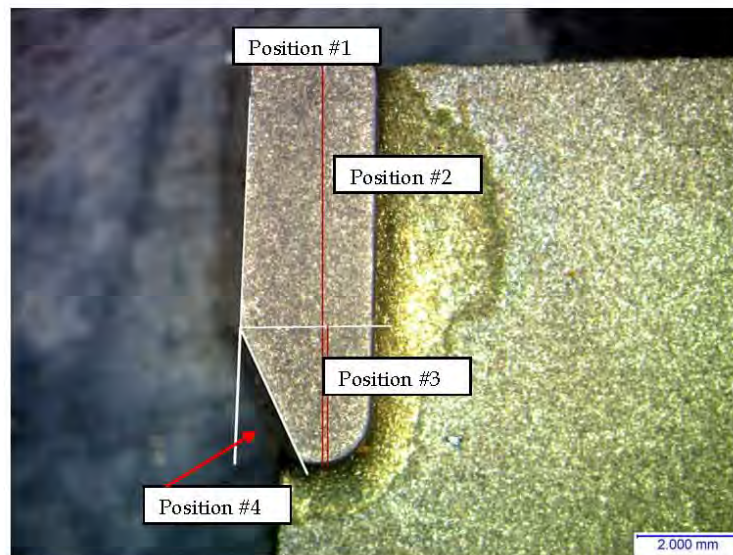
Tooth #	Position # 1 (mm)	Position # 2 (mm)	Position # 3 (mm)	Position # 4 (mm)
1	2.415	7.876	2.736	27.058
2	2.482	7.855	2.859	27.115
3	2.438	7.832	2.714	25.841
4	2.448	7.810	2.769	26.732
5	2.426	7.910	2.603	26.388
6	2.393	7.766	2.615	27.084

Figure 2: Macrograph of Circular Saw CTB 11 3/4-24, before testing, showing position locations

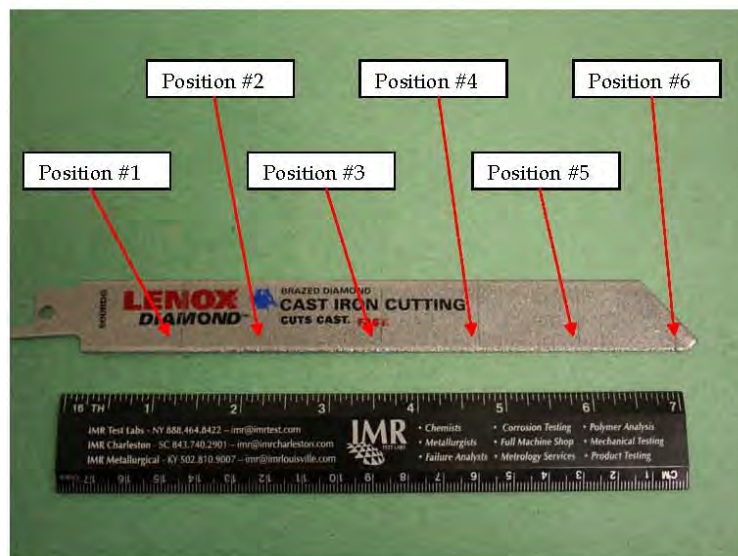
Position #	Results (mm)
1	19.530
2	19.648
3	19.532
4	19.492
5	19.488
6	19.516

Figure 3: Macrograph of Lenox Diamond 800RDG before testing, showing position locations

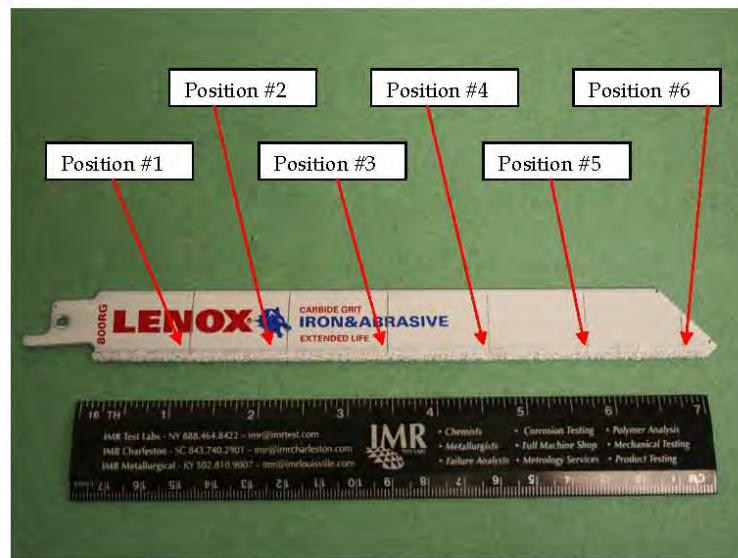
Position #	Results (mm)
1	19.790
2	19.646
3	19.768
4	19.736
5	19.720
6	19.802

Figure 4: Macrograph of Lenox Iron & Abrasive 800RG before testing, showing position locations

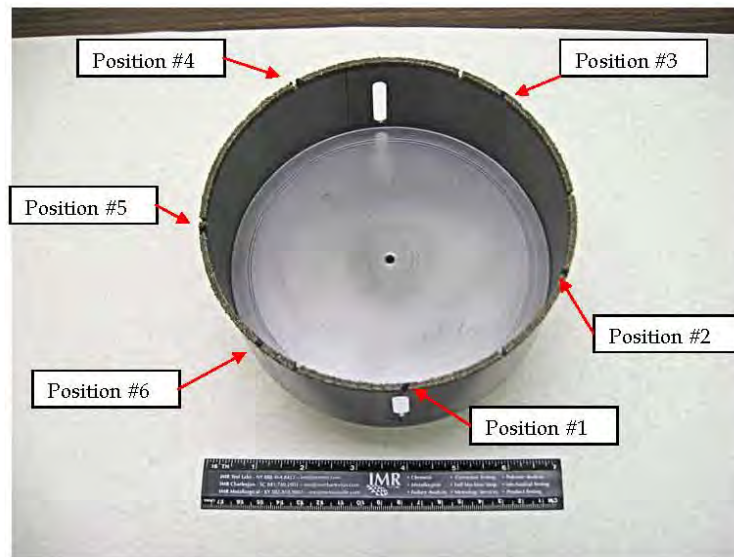
Position #	Results (mm)
1	64.826
2	64.888
3	64.934
4	64.922
5	64.966
6	65.142

Figure 5: Macrograph of Hole Saw P26761 before testing, showing position locations

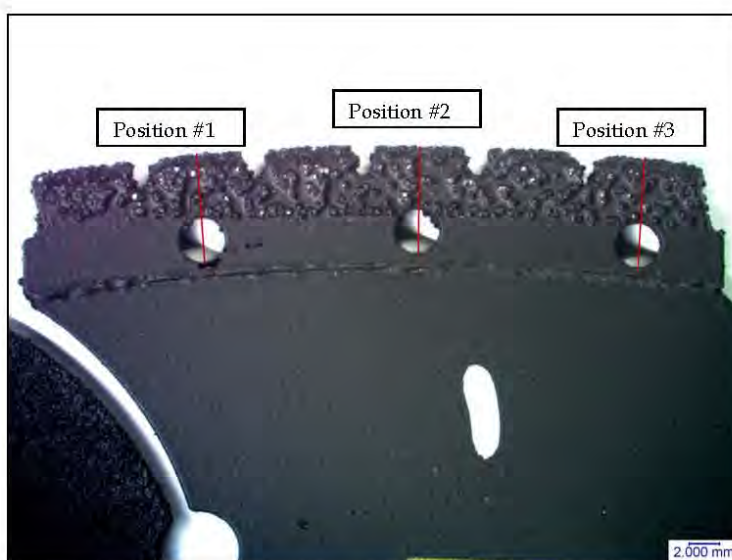
Tooth #	Position # 1 (mm)	Position # 2 (mm)	Position # 3 (mm)
1	7.196	7.063	7.196
2	7.067	7.238	6.968
3	7.121	7.177	7.120
4	7.064	6.897	7.132
5	7.231	7.118	7.080
6	7.288	7.006	7.070

Figure 1: Macrograph of Circular Saw NDL 18772 no. 2, before testing, showing position locations

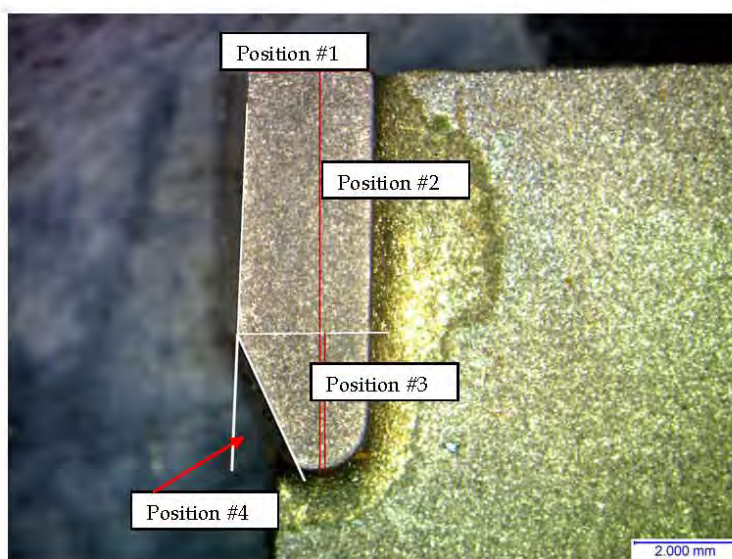
Tooth #	Position # 1 (mm)	Position # 2 (mm)	Position # 3 (mm)	Position # 4 (degree)
1	2.326	7.979	2.513	23.495
2	2.409	8.009	2.476	22.650
3	2.426	8.042	2.492	22.848
4	2.410	8.026	2.476	24.570
5	2.394	8.026	2.542	24.921
6	2.343	7.959	2.493	23.851

Figure 2: Macrograph of Circular Saw CTB 11 3/4-24 no. 2, before testing, showing position locations

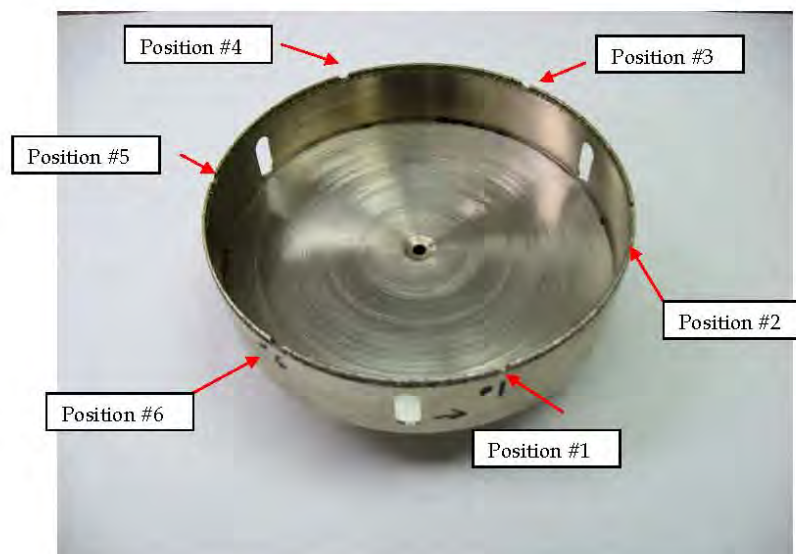
Position #	Results (mm)
1	35.454
2	35.592
3	35.412
4	35.788
5	35.460
6	35.620

Figure 3: Macrograph of Hole Saw 152 mm before testing, showing position locations

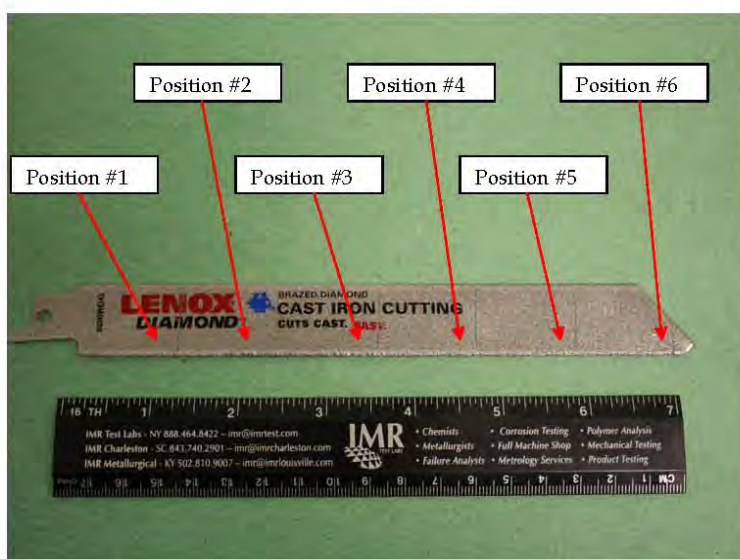
Position #	Results Before Test (mm)	Results After Test (mm)
1	19.530	19.450
2	19.648	19.550
3	19.532	19.488
4	19.492	19.352
5	19.488	19.362
6	19.516	19.440

Figure 4: Macrograph of Lenox Diamond 800RDG before and after testing position locations

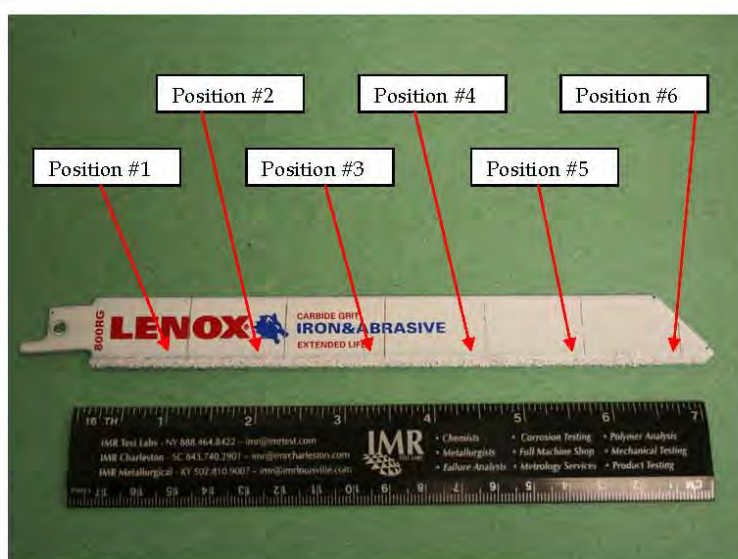
Position #	Results Before Test (mm)	Results After Test (mm)
1	19.790	19.580
2	19.646	19.550
3	19.768	19.498
4	19.736	19.474
5	19.720	19.582
6	19.802	19.630

Figure 5: Macrograph of Lenox Iron & Abrasive 800RG before and After test position locations

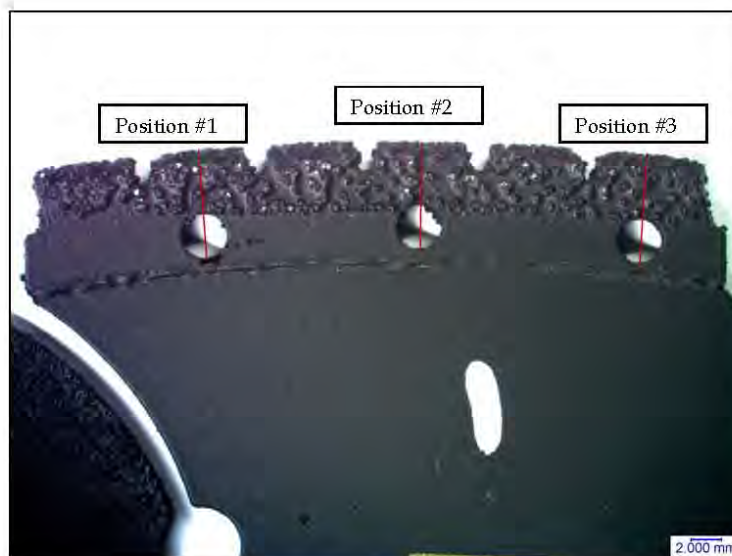
Tooth #	Position #1 Before Test (mm)	Position # 1 After Test (mm)	Position # 2 Before Test (mm)	Position # 2 After Test (mm)	Position # 3 Before Test (mm)	Position # 3 After Test (mm)
1	7.193	7.143	7.062	7.044	7.262	7.189
2	7.072	7.064	7.211	7.063	7.188	7.118
3	7.137	7.062	7.175	6.912	7.153	7.062
4	7.377	7.231	7.211	7.185	7.202	7.099
5	7.099	6.964	7.212	7.179	7.333	7.232
6	7.111	6.895	7.101	7.020	7.142	6.951

Figure 6: Macrograph of saw blade, showing before and after testing position locations

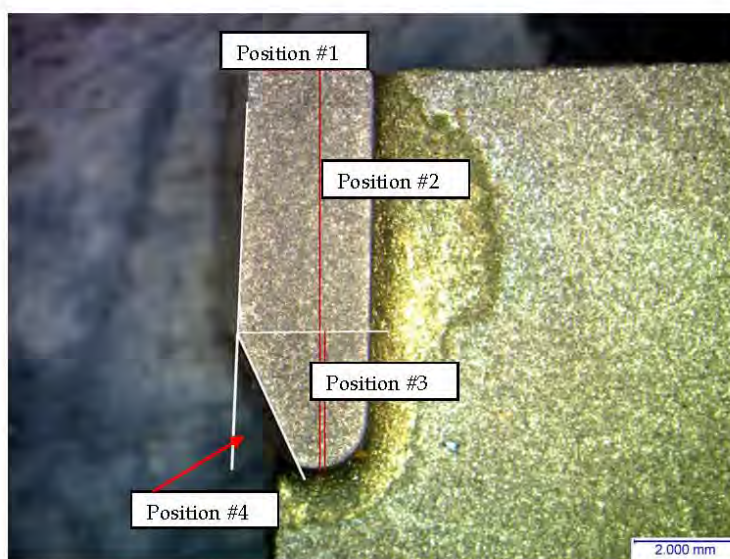
Tooth No.	Position # 1 Before Test (mm)	Position # 1 After Test (mm)	Position # 2 Before Test (mm)	Position # 2 After Test (mm)	Position # 3 Before Test (mm)	Position # 3 After Test (mm)	Position # 4 Before Test (mm)	Position # 4 After Test (degree)
1	2.415	2.331	7.876	7.717	2.736	2.546	27.058	25.525
2	2.482	2.311	7.855	7.703	2.859	2.768	27.115	26.402
3	2.438	2.349	7.832	7.741	2.714	2.554	25.841	27.237
4	2.448	2.270	7.810	7.783	2.769	2.467	26.732	26.720
5	2.426	2.309	7.910	7.680	2.603	2.440	26.388	26.683
6	2.393	2.375	7.766	7.623	2.615	2.493	27.084	27.320

Figure 7: Macrograph of Circular Saw CTB 11 3/4-24, before and after testing position locations
